3115 N. Broadway – Building and Façade History

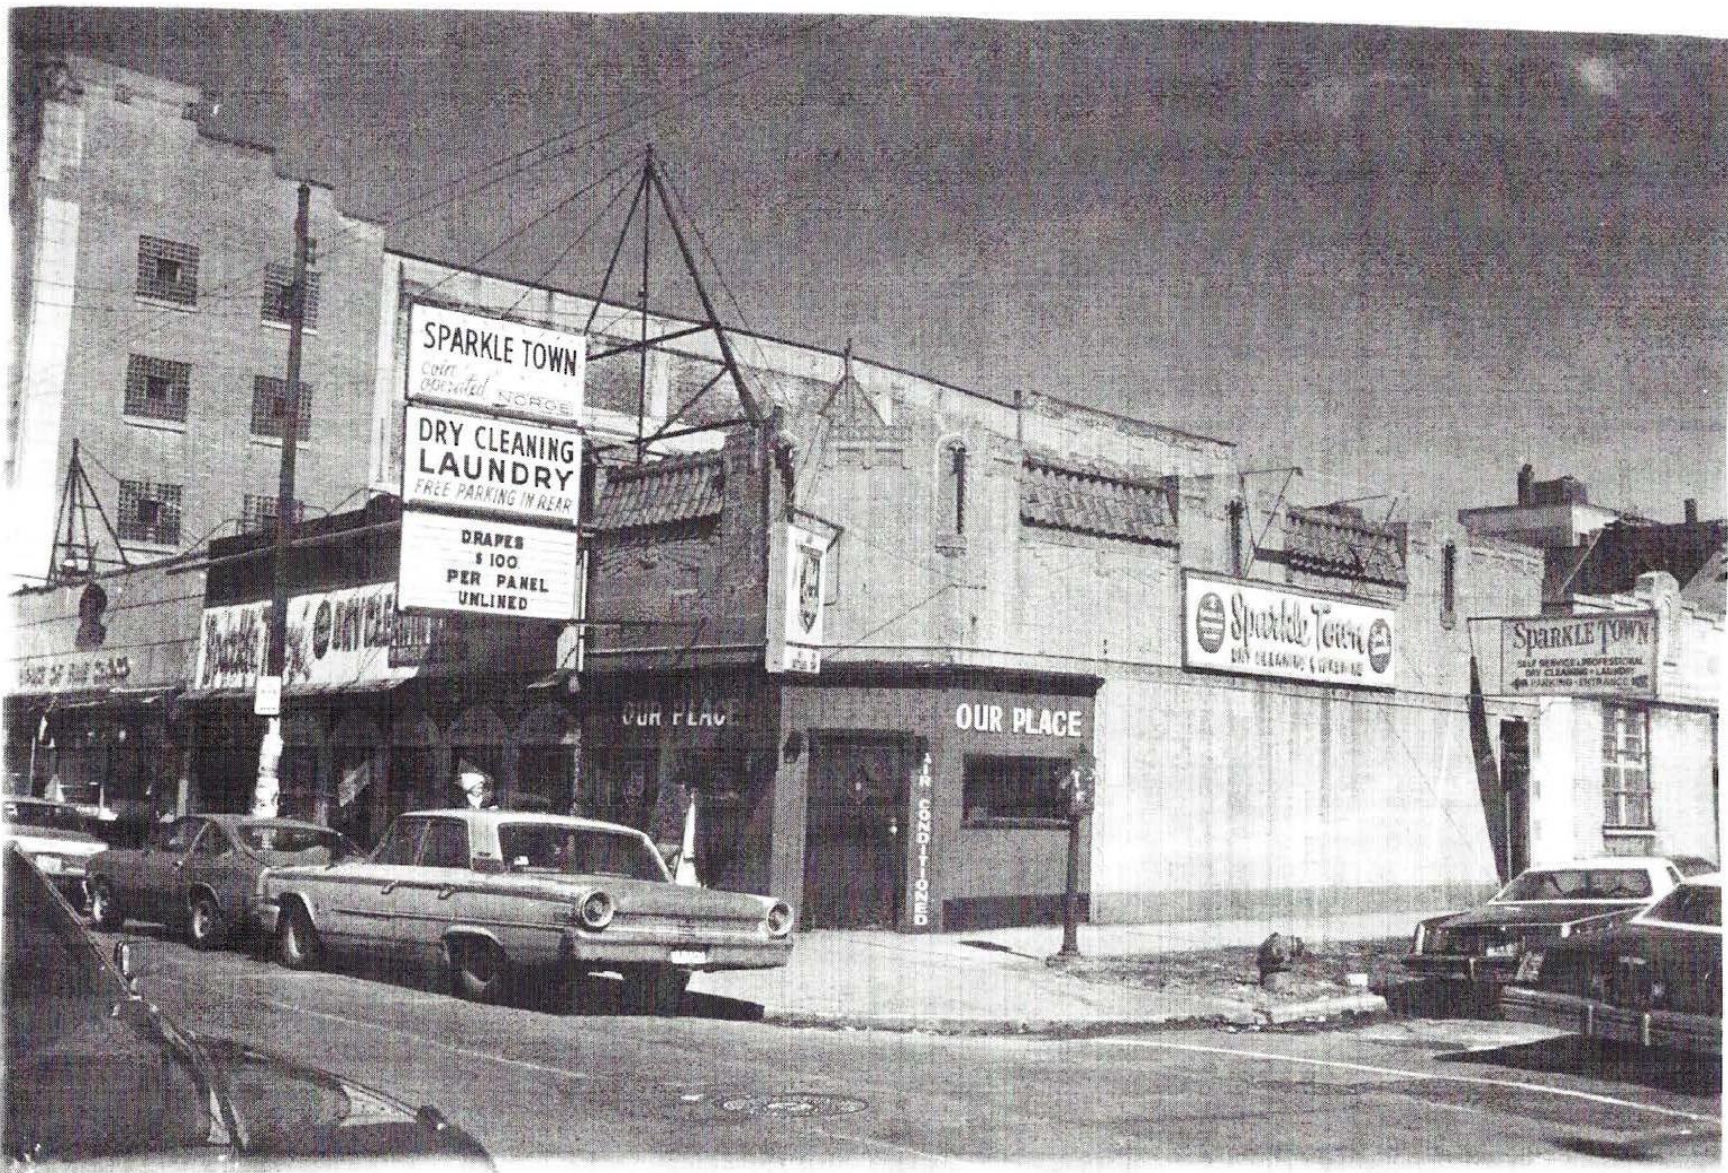
Photograph of south elevation – April 1975

This photo was found, showing the south elevation and the quoins in place before the EFIS was clad over.

The eagles running across the parapet were also visible.

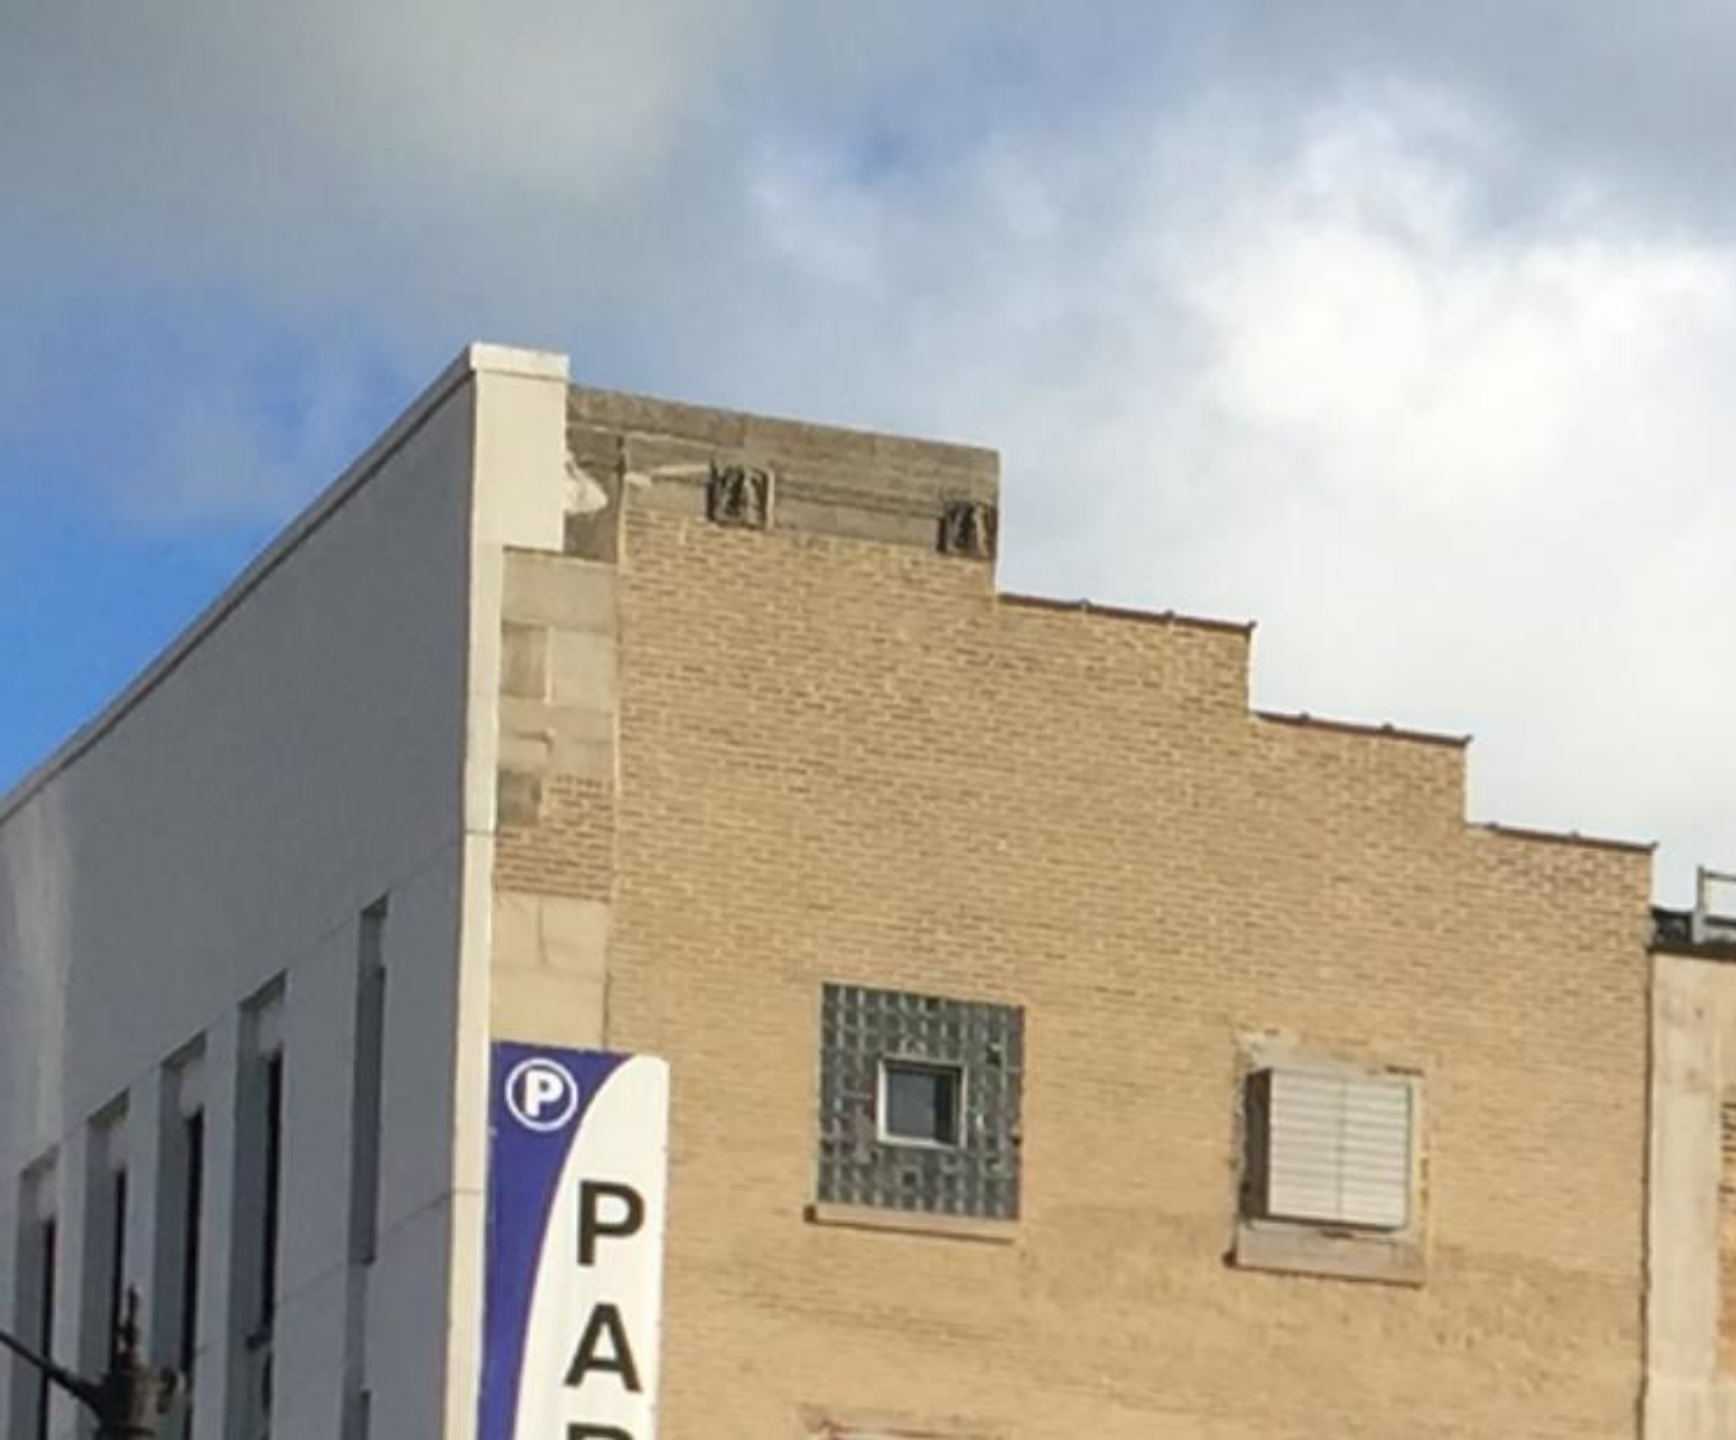
South Elevation – Present Day

After seeing the eagles in the photo from 1975, we confirmed they were still in tact on the south and north elevation.

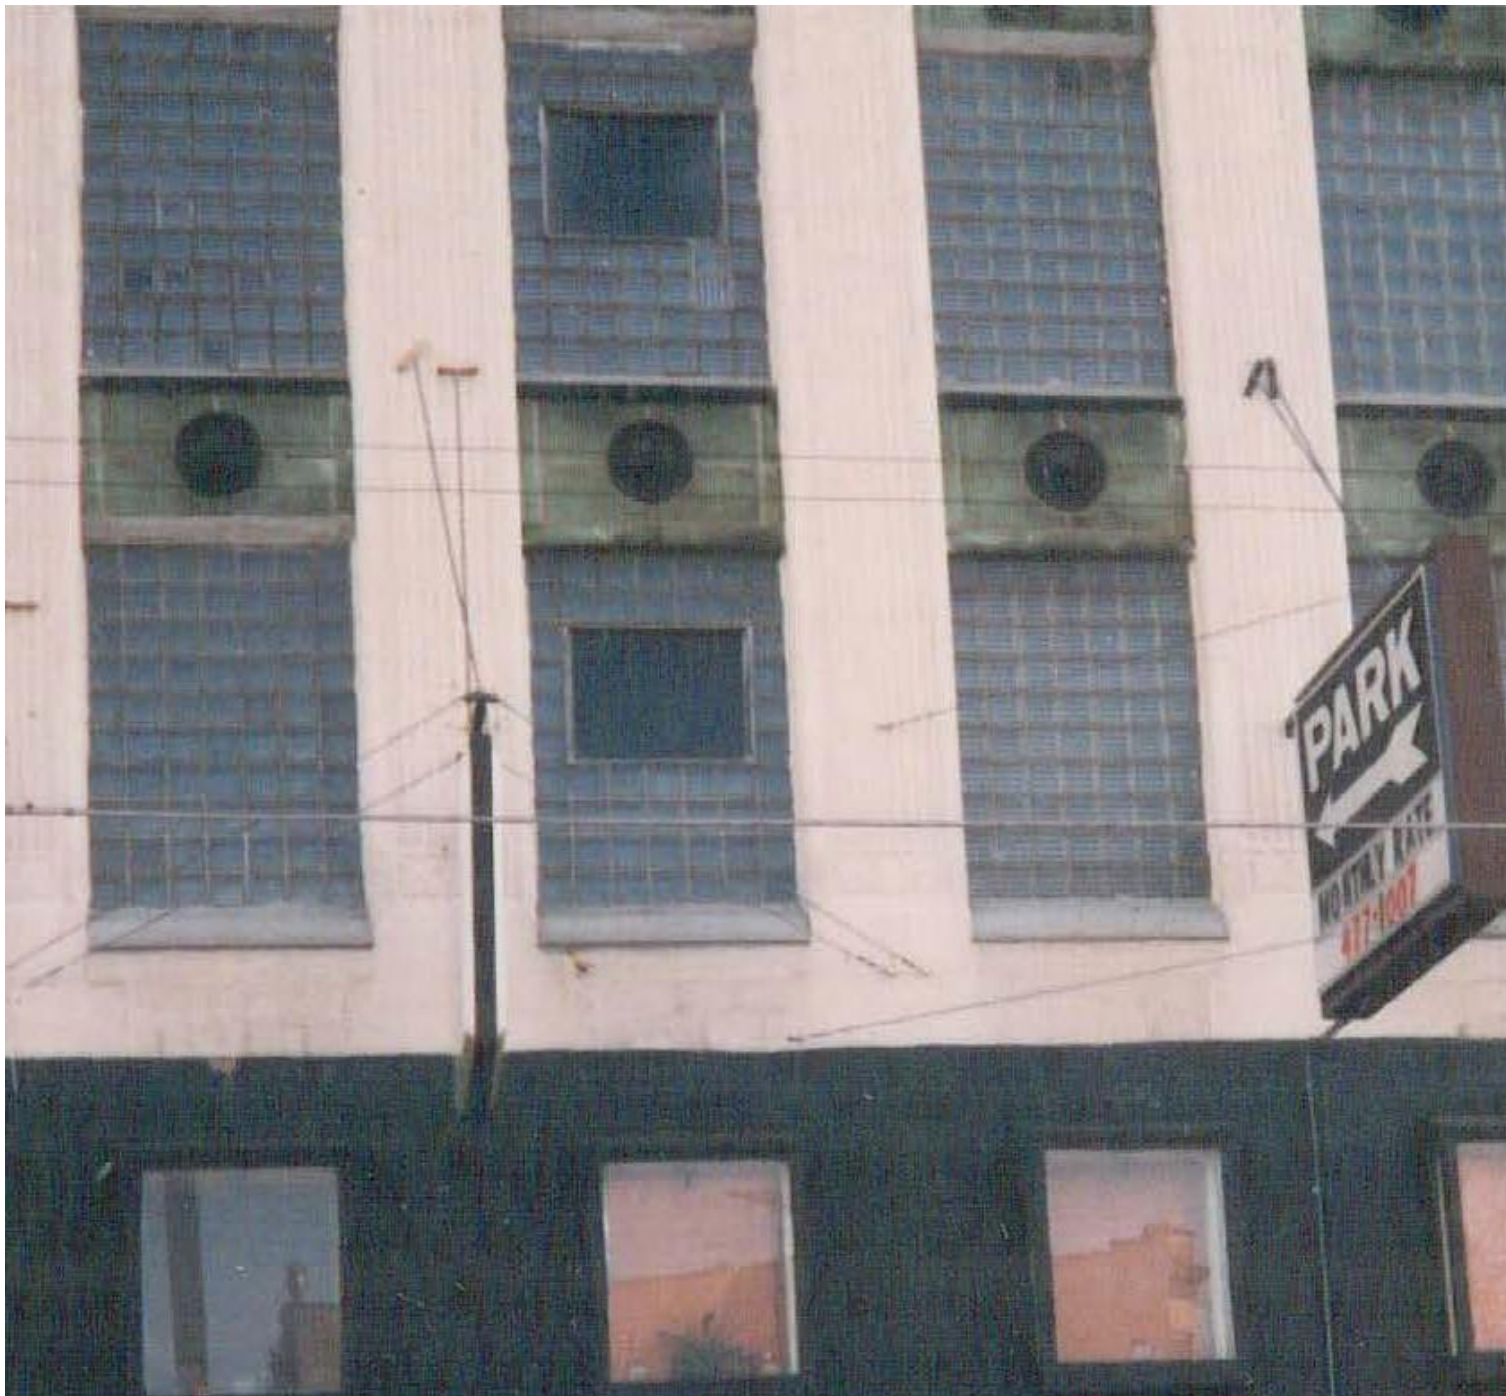
Façade Detail before EFIS

Along with the photo revealing the eagles, we noticed the fluting detail of the columns in this photo.

At this point we decided to investigate and find out what existed behind the EFIS.

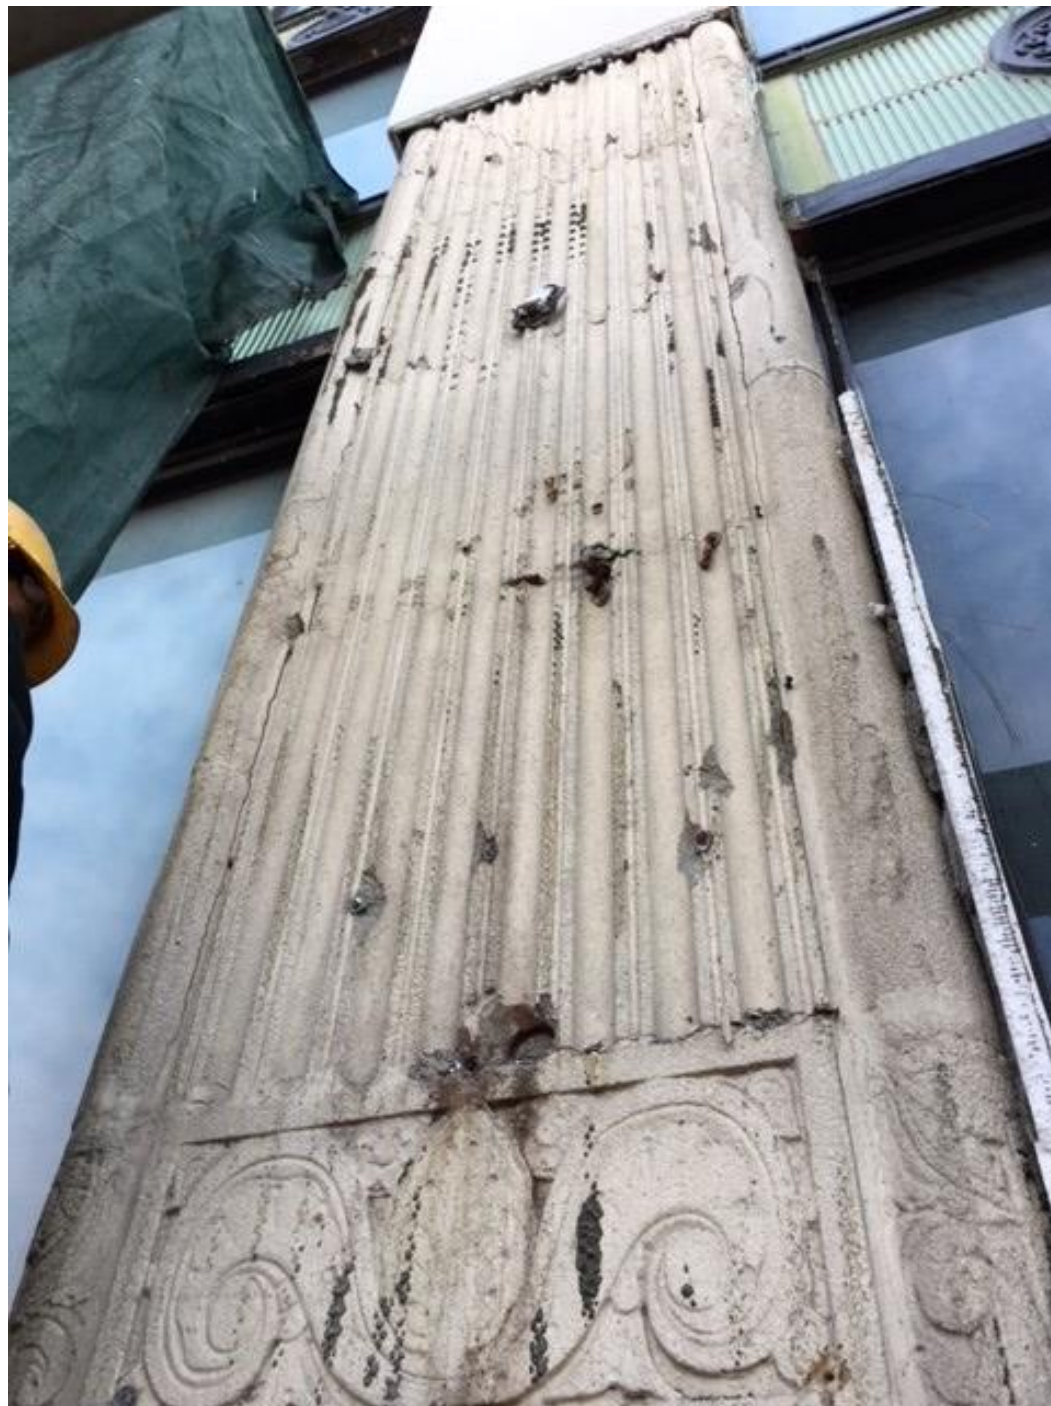
Façade Investigation & Column Fluting

We quickly learned there was something unique behind the EFIS, which inspired the design we're presenting today.

This photo represents what we believe to be a typical section of the column design, highlighted by its fluting, rounded edges and detailed base design.

We intend to repair this façade to a level of quality as originally designed and completed in the early 1930's.
